## *Alatech Home Inspection Service*

**October 21, 2017**

**100 Maple Lane  
Hog Jaw, USA**

**Mr. John Smith**

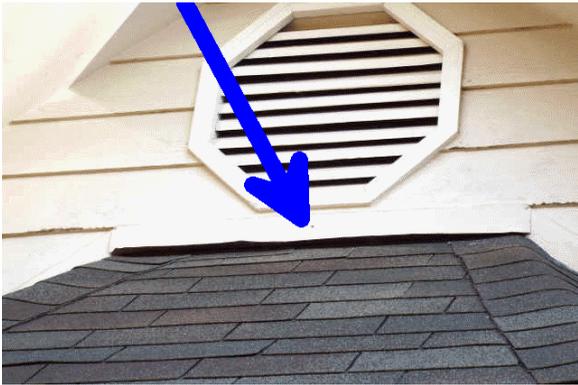
The roof/wall flashing is loose on the front.

**Repair:** The metal flashing at the front dormer is loose or damaged and may allow water to enter the attic. Securing or replacing all loose or damaged flashings to restore full function is suggested.

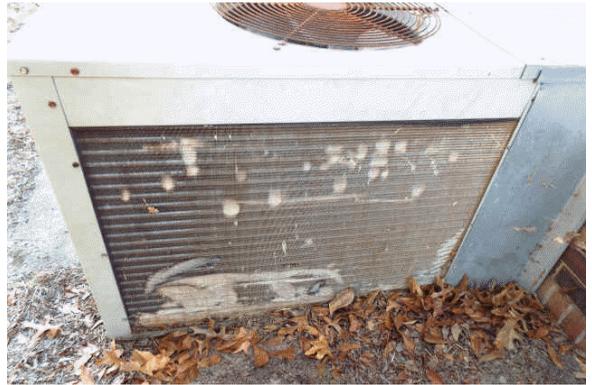
The aluminum fins are bent on the A/C unit.

**Repair:** The exterior condensing unit has bent or flattened aluminum fins, blocking airflow through the coil and decreasing the efficiency of the unit and potentially damaging internal components.

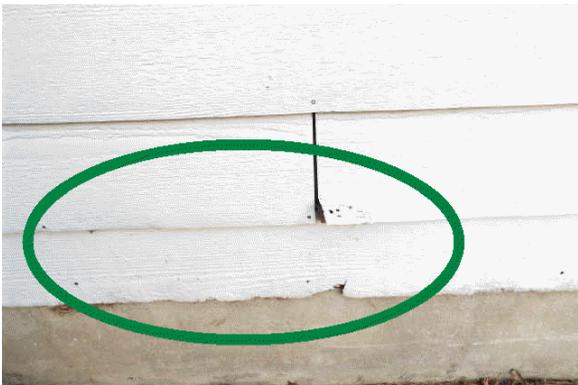
The damaged siding needs to be replaced.

**Repair:** Localized rot was observed in the siding. Following repair of the damaged areas (which should be combined with exterior painting/maintenance) proper maintenance of the siding and control of water from roof or surface runoff can avoid further damage.

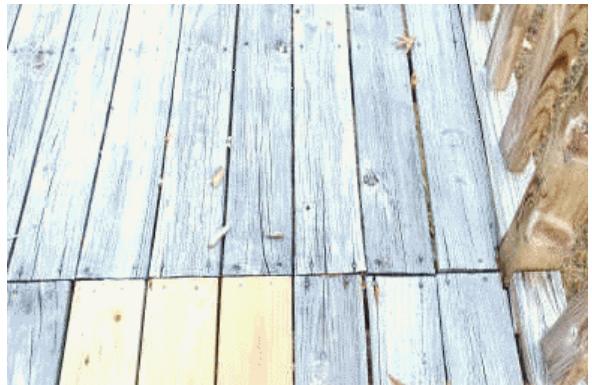
The planks are cracking on the deck.

**Major Concern:** The deck shows evidence of weathering and cracking of the 1x6 flooring. When cracking is visible it indicates that the wood is weaker and could break. In the interim, localized repairs could be undertaken, but replacement is the best long term approach.

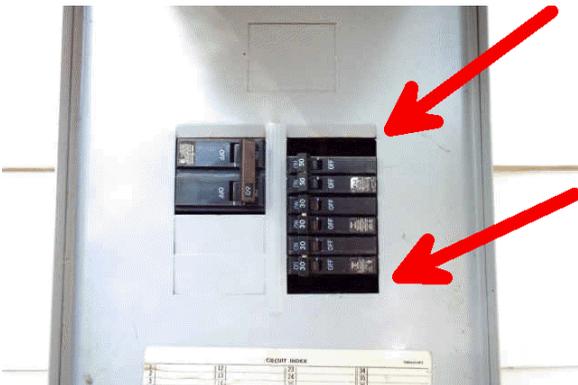
The openings in the main panel need to be sealed.

**Safety Issue:** An opening or "unoccupied" hole was observed in the main service panel where a "knockout" had been removed. **SUGGESTION:** All openings should be sealed to prevent objects or fingers from being inserted into the openings. The panel should be modified, repaired or augmented as necessary to insure that it is safe by a qualified licensed electrician.

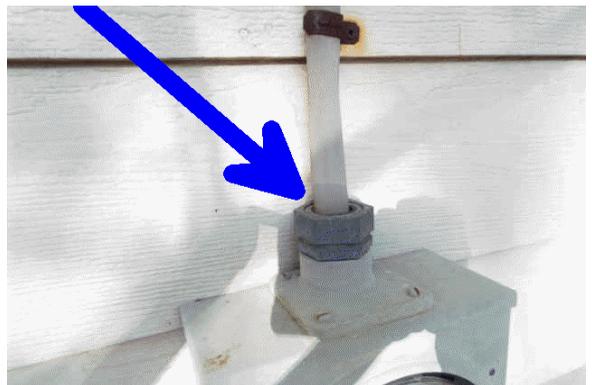
The electrical service cable needs to be caulked. The rusty clamp is staining the siding.

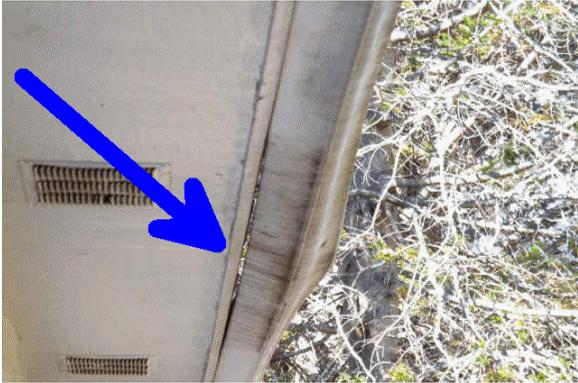
The gutter on the rear is loose.

**Repair:** The gutter is loose or pulled away from the fascia on the rear side of the structure.

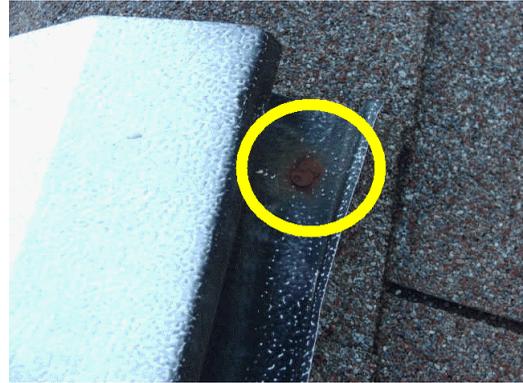
The exposed nail heads at the ridge vent need to be sealed.

**Repair:** Exposed nail heads at the ridge vent needs to be sealed to insure moisture does not enter around the heads.

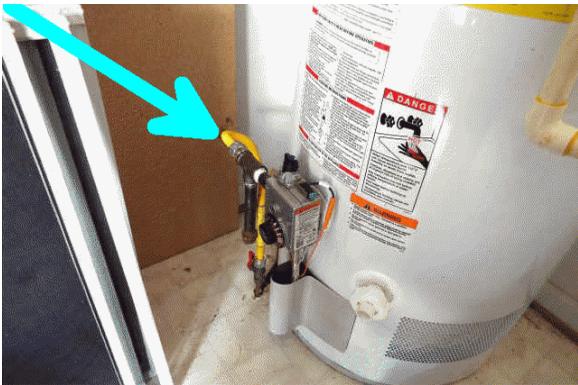
The CSST appliance connector noted at the water heater.

**Safety Issue:** The structure has corrugated stainless steel piping (CSST) used to connect the gas piping to the water heater located in the carport closet. For several years, there have been reports of damage to CSST installations in buildings that were struck by lightning, including breaks in the tubing and ignition of the fuel gas and the surrounding structure. The early reports were not always considered credible, even though firefighters recognized the breaks in the system and the burning gas. It was noted that this damage could be due to the small mass of CSST compared to black steel pipe. As the documented history of these incidents developed, tests were conducted which proved that lightning could damage CSST gas piping, and which suggested a way to reduce the possibility of lightning damage.

The CSST must be bonded only at the end nearest the entry of the gas service into the building. If it is bonded at both ends, or at the end nearest the gas-burning appliance, the CSST may carry stray electrical currents or act as a grounding conductor, which can damage the CSST and its fittings, and cause leaks.

There has been a history of lightning damage to the flexible piping and has caused fires.

**(Suggestion) Replacing the gas line with copper would be easier and less costly or replace the pipe with a newer design of connector with a gas safety shut off valve.**

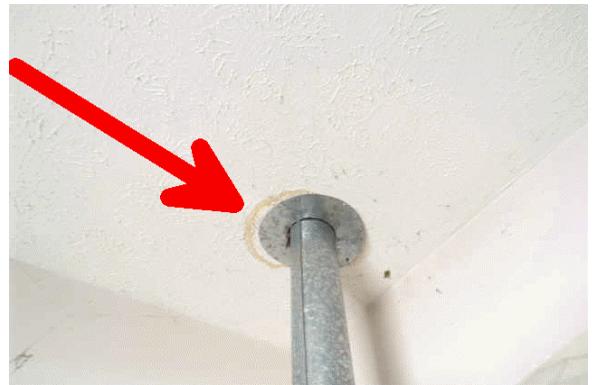
Water stain noted at the water heater flue.

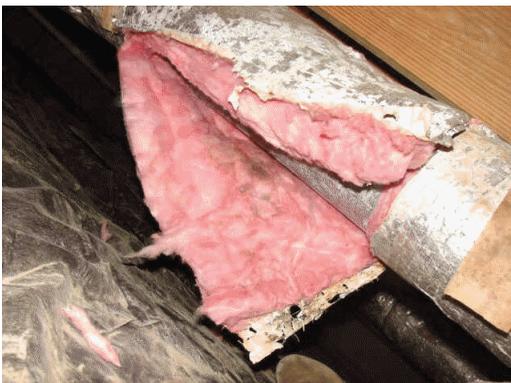
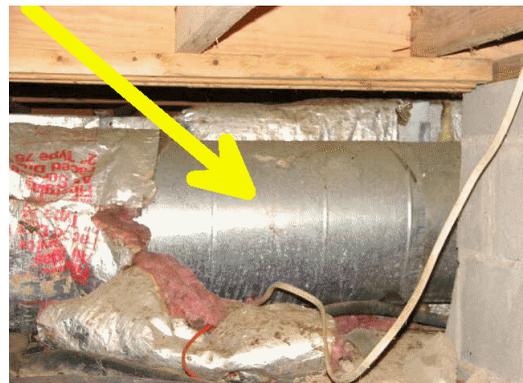
The loose insulation around the A/C duct needs to be replaced.

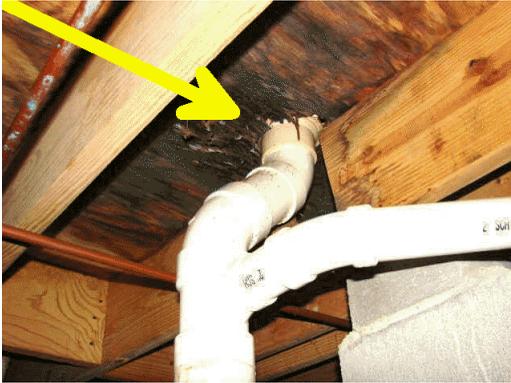
The water damaged subfloor and the cut joist needs to be supported.

**Repair:** The floor structure shows evidence of minor rot under the bathroom. Rot weakens the structure and causes distress to the building. Damaged wood should be repaired or replaced and the conditions that have promoted the rot (such as wet conditions and/or poor ventilation) should be remedied.

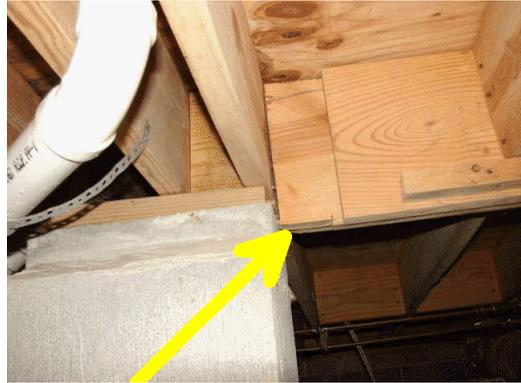
The connection at the beam needs to be supported.

**Repair:** The beam at the pier lacks proper support. While this does not pose a serious short term problem, it may allow for excessive sagging of the beam over time. Additional support may be needed.

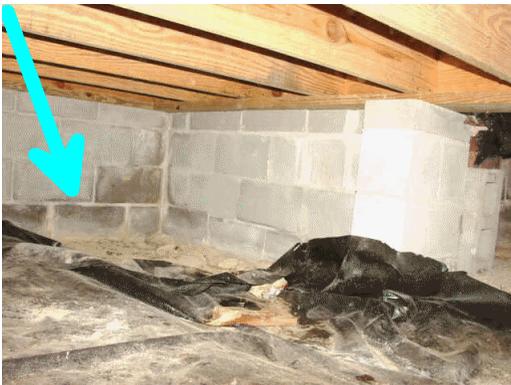
Water stain noted at the front foundation.

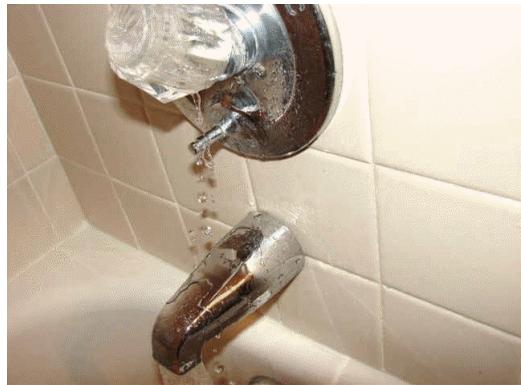
Water leaks at the shower faucet.

**Repair:** Water leaks around the faucet handle on the hall bathroom tub when opened.

SUGGESTION: All leaking faucets should be repaired or replaced by a qualified technician to restore proper function.
